# COCA-COLA REFRESHMENTS EQUIPMENT BULLETIN GENERAL

**NUMBER:** GEN-140

**SUBJECT:** ABS Cup Grabber Block Improvements

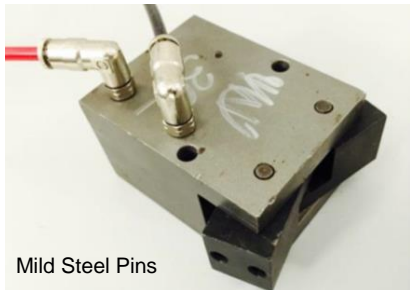
Mild Steel Pins

Floating O-Ring Piston
Mild steel pins ➔ Stainless steel pins	Spiral clip-contained o-ring ➔ Groove-contained o-ring	Conventional seal ➔ Floating seal
Eliminates corrosion-related jamming of arms	Eliminates leaking end caps	Reduces incidence of leaking across the piston

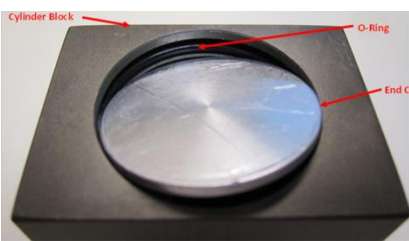
Cylinder Block O-Ring End Cap

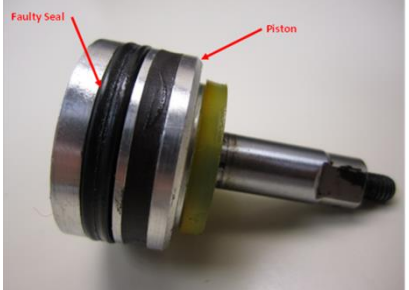
Faulty Seal Piston
NEW

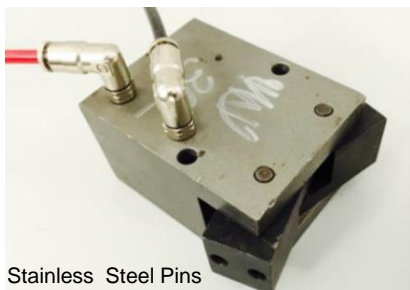
Stainless Steel Pins
