COCA-COLA FOUNTAIN EQUIPMENT BULLETIN..... SERVICE

NUMBER : SERV - #195

SUBJECT : ABS Lift Cylinder Sensor Diagnosis

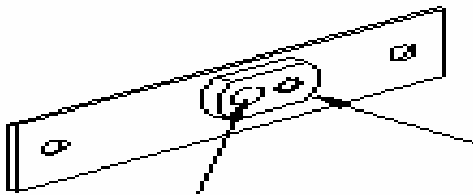
The current switch bracket on the lift cylinder may compress the switch between the bracket and cylinder causing the contactors inside the switch to bind. A new switch bracket has been created which is not subject to this compression.

Figure 1: old switch bracket

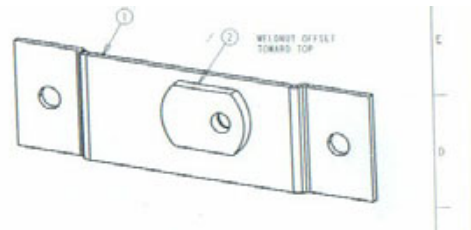
Figure 2: new switch bracket

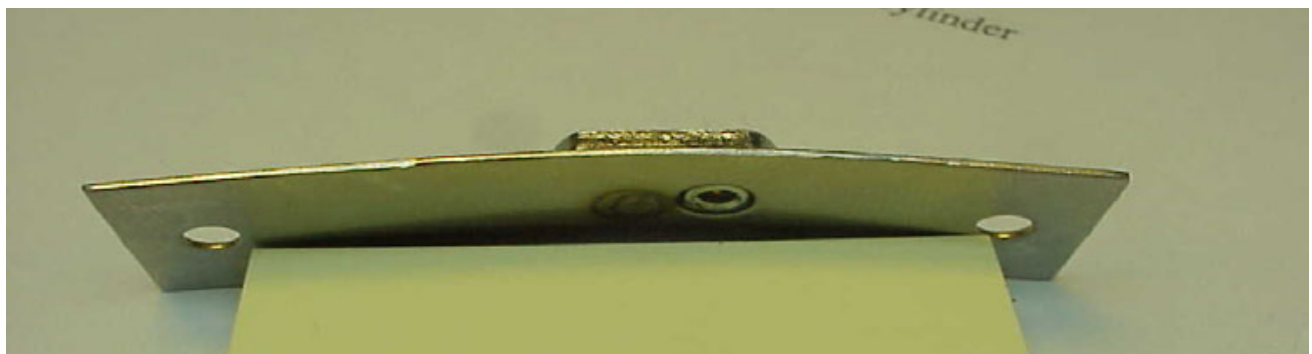
- 1) Is the switch bracket the old (Figure 1) or the new (Figure 2) configuration?
- 2) Binding can occur on the old switch when the bracket warps (Figure 3) and the switch comes in direct contact with the cylinder. Warping is caused by over-tightening the screws on the bracket. If you have an old switch bracket, make sure that there is a gap between the switch and cylinder. You can do this using a dollar bill or similar small piece of paper (see Figure 4)

Figure 3: warped switch bracket

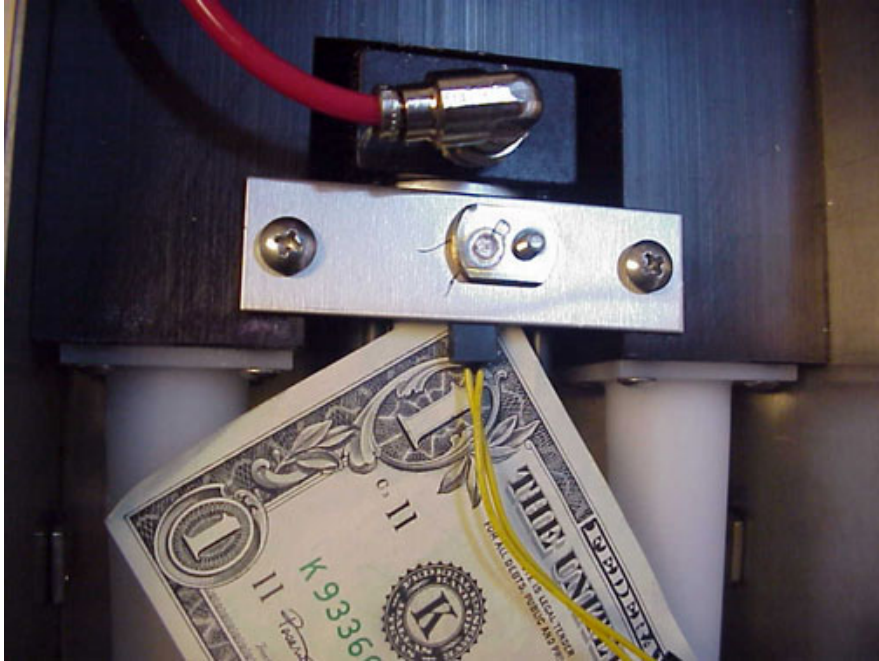
Figure 4: checking for space between the switch and the cylinder
