COCA-COLA REFRESHMENTS EQUIPMENT BULLETIN GENERAL

NUMBER: GEN-144 Rev. A

SUBJECT: ABS Lift Cylinder Improvements for Remanufacturing

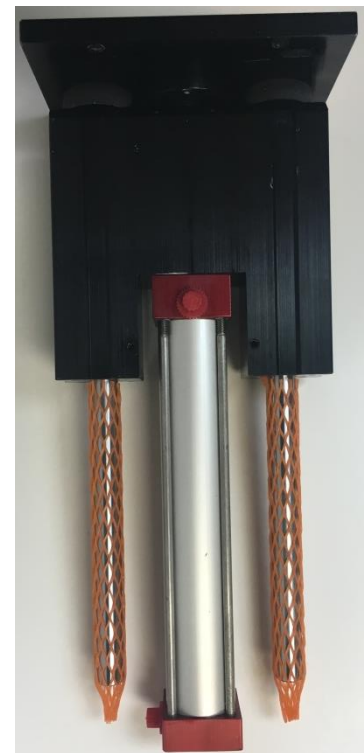
Two failure modes were found and design improvements made against each.

1. Accelerated Rod Seal Wear

2. Piston Seal Wear

- The piston rod-platform joint allows the rod to center itself and not pinch the seal.
- The rod guides are now bronze and sealed against syrup ingress.
- The rod bushing design better locates the rod.

- The piston seal has improved life and better locates the piston and rod in the assembly.
- The end caps are easier to assemble correctly.
- The screws holding the assembly together were replaced with stainless steel to resist corrosion and allow for easy rebuilding of the cylinder assembly.

All design improvements will be added to reman parts. All cylinders are expected to wear in operation and require periodic rebuilding. This redesign has been developed for just that purpose, and the part can be rebuilt as many times as necessary.

Dieb cylinders (new and remanufactured) can be identified by their red caps.
